SOIL LIQUEFACTION AND EFFECTS ON STRUCTURES; CASE STUDY IN ADIYAMAN- GÖLBAŞI AFTER THE 06 FEB 2023 EARTHQUAKES IN TÜRKİYE

Abstract. On 06 FEB 2023, two earthquakes occurred southeast of Türkiye; Kahramanmaraş-Pazarcık ($M_w=7.8$) and Kahramanmaraş-Elbistan ($M_w=7.6$). These earthquakes caused devastating effects in 11 cities in eastern Turkey and northern Syria. This study presents the post-earthquake discoveries in three liquefied areas during earthquakes and four buildings in these liquefied areas in the Gölbaşı District of Adıyaman City. First, an important role of post-earthquake piezocone penetration test (CPTu) in the characterization of subsurface conditions and assessment of liquefaction hazard is presented. Then, the effect of soil liquefaction on the performance of the buildings in these regions during the earthquake was investigated. These structures consist of 3- to 6-stories on raft foundations and exhibited various structural performances. Based on the interim findings from these areas, potential factors that cause moderate to severe damage to buildings were examined, and preliminary information on the relationship between soil properties, and the performance of bui

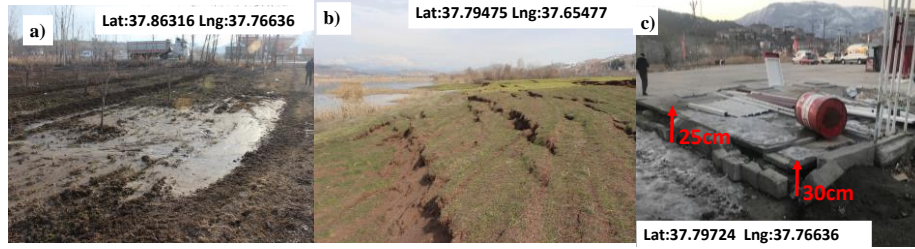
The signs of seismic soil liquefaction in free-field, near the Gölbaşı lake zone, were observed in the form of sand/silt boiling (Figure 2a) and lateral spreading (Figure 2b). Earthquake-induced liquefaction can also severely damage infrastructures and buried pipelines in susceptible zones [8,9]. During the event, an embedded fuel tank of a gas station uplifted about 25cm due to liquefaction, as seen in Figure 2c. The street pavement cracking symptoms due to lateral spreading were also commonly observed.

Fig 2. Some of the seismic liquefaction symptoms (a) sand/silt volcanoes, (b) lateral spreading near the Golbasi Lake, and (c) fuel tank uplift in Gölbaşı City Center

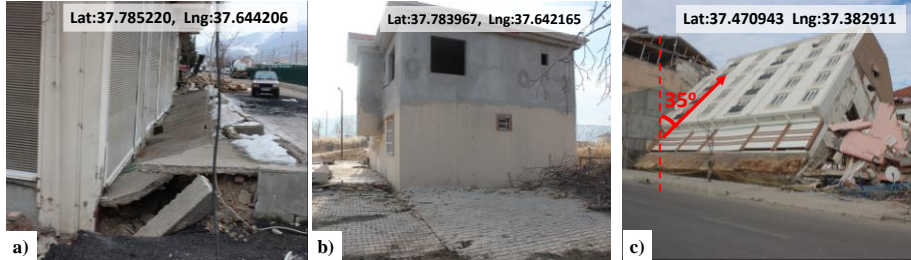
In addition to the free-field areas, great damage to buildings has been caused by liquefaction. The types of evidence due to liquefaction observed at the edges of residential buildings were sand volcanoes and lateral spreading. Many building foundations have also been subjected to excessive settlements (Figure 3a) and bearing capacity failures such as punching failure (Figure 3b) and overturning of the buildings due to seismic soil liquefaction. An extreme example of the overturning of a residential building in Gölbaşı-Adıyaman, as a result of exceeding the bearing capacity due to liquefaction, is shown in Figure 3c. The raft foundation thickness of this building was measured as 80cm. This building, which was lying on its side at the order of $15\text{--}20^\circ$ in the first earthquake, was subjected to rotation above the order of 35° after the second earthquake and leaned on the structure behind it.

Fig 3. (a) Lateral spreading and excessive settlement, (b) punching failure, and (c) overturning of buildings in Gölbaşı

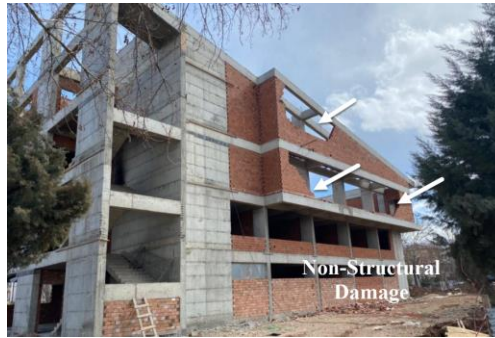
The A-1 building (at Site A) is a 4-story, 10.5-m high structure, which is 16m wide (E-W) and 31.35m long (N-S) (Figure 5). It is known that it was started to construct in 2022. The foundation consists of a 0.6-m thick raft foundation and is embedded 1.4-m deep. The jet grout columns with a diameter of 100cm, length of 30m, and grid value of 1.50m were applied before construction. No significant building movement, structural or geotechnical damage is noted after the events.

Fig 5. Building A-1 right after the 06 FEB 2023 earthquakes (37.79198°N, 37.64886°E)

Moreover, the post-liquefaction volumetric reconsolidation settlement at the free field up to 2m depth was calculated [3] and plotted in Figure 6e. The settlement at the ground surface was calculated to be 69.5mm. No liquefaction manifestation was observed at Site A. According to the laboratory tests before the earthquake, from 1.5m to 2.5m, the average plasticity index (PI) was determined as 32. From 5.0 to 7.5m, the average PI is determined as 20 (Figure 6f). There was no settlement measured at building A-1 (Table 1). The improvement of the foundation soil below the building by jet grout columns can be the reason for having no manifestation of liquefaction failure at the building.

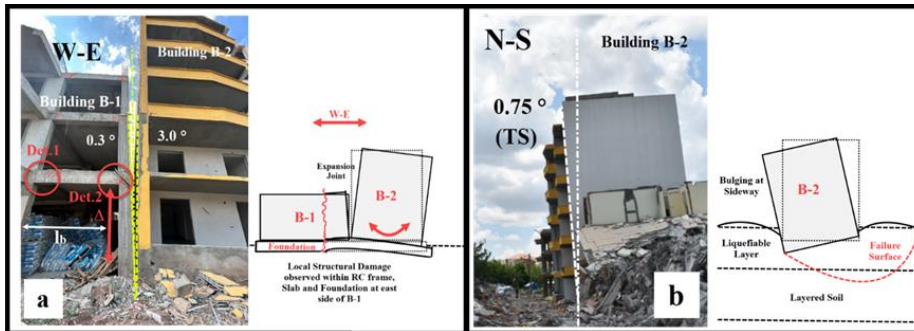
At site B, the geotechnical investigation and building construction design of two separate structures, B-1 and B-2, were investigated. The buildings were approximately 830m away from the lake. Before the events, the construction of the B-1 building had progressed up to the third-floor level, and the B-2 structure (freshly completed in 2023) consisted of a ground floor, five stories, and a roof. Notably, even though the structural frames are separated by an expansion joint, the B-1 and B-2 structures were established upon a unified 0.7m thick raft foundation (Figure 7a). The ground floor slab is 150mm thick. There were no applied soil improvements before the earthquakes below the buildings. After the earthquakes, severe liquefaction signs were observed throughout Site B, especially along the side of the B-2 building.

Fig 7. Photo and schematic view of liquefaction-induced displacement mechanism (a) B-1 and B-2 buildings, E-W direction, and (b) B-2 through N-S direction (37.7872° , 287.376421°)

Notwithstanding the substantial geotechnical damages, such as notable total and differential settlements and tilt in the B-2 building, structural damage was not readily visible within the context of the structure. However, structural damages in building B-1 at the neighboring span to building B-2 were observed. Noticeable indications of substantial geotechnical damage were not witnessed within the B-1 structure. The observed damage in the building supports that due to the dynamic motion and rota-

tional response of the B-2 building during the seismic event, considerable damage was created at the adjacent B-1 structure. The structural damage in the B-1 building indicates a major downward movement on the east side of the building (Figure 7a). The localization of the damage to a limited area and with the defined mechanism at the boundary with the B-2 building shows that this damage is not due to the ground motion demands. The remarkable rotation of B-2 and shear failure of soil caused a tilt of 0.34° between B-1 and B-2 frames (Table 1).

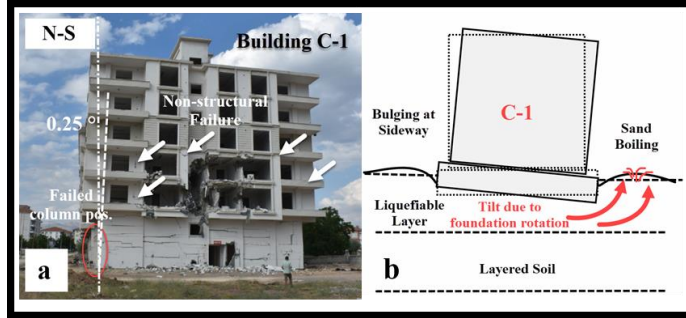
At Site C, the geotechnical investigation and building construction design of one 6-story residential building, C-1 (Figure 9a), which was freshly constructed and moderately damaged, was investigated. Building C-1 was approximately 1700m southwest of the lake, with a GWL depth of about 0.1m. The structure was supported on a raft foundation with a thickness of 160cm. In the vicinity of the site, there were two more similar six-story buildings. Grouting with a height of 6m and grid value of 2.5m was performed below the foundation.

Fig 9. Building C-1 after the 06 FEB 2023 earthquakes, a) photo and b) schematic view of tilt in N-S direction due to geotechnical and structural damages (37.78037° , 37.6284°)

Following the events, severe liquefaction of the foundation soils induced significant total and differential settlements of the building, leading to structural distortions and cracking. The differential settlement of 8cm was observed at the S-E corner of the structure relative to its N-W corner. Furthermore, this building experienced displacement towards the north (23mm). The building tilt obtained from the differential settlement at the foundation corners was reported as 0.95° (toward west) and 0.25° (toward south) (Table 1). Severe levels of liquefaction-induced sand/silt ejecta were observed around the structure. Additionally, lateral spreading phenomena were detected on the vacant land on the southern side of the building.
