SOIL LIQUEFACTION AND EFFECTS ON STRUCTURES; CASE STUDY IN ADIYAMAN- GÖLBAŞI AFTER THE 06 FEB 2023 EARTHQUAKES IN TÜRKİYE

Abstract. On 06 FEB 2023, two earthquakes occurred southeast of Türkiye; Kahramanmaraş-Pazarcık ($M_w=7.8$) and Kahramanmaraş-Elbistan ($M_w=7.6$). These earthquakes caused devastating effects in 11 cities in eastern Turkey and northern Syria. This study presents the post-earthquake discoveries in three liquefied areas during earthquakes and four buildings in these liquefied areas in the Gölbaşı District of Adıyaman City. First, an important role of post-earthquake piezocone penetration test (CPTu) in the characterization of subsurface conditions and assessment of liquefaction hazard is presented. Then, the effect of soil liquefaction on the performance of the buildings in these regions during the earthquake was investigated. These structures consist of 3- to 6-stories on raft foundations and exhibited various structural performances. Based on the interim findings from these areas, potential factors that cause moderate to severe damage to buildings were examined, and preliminary information on the relationship between soil properties, and the performance of bui

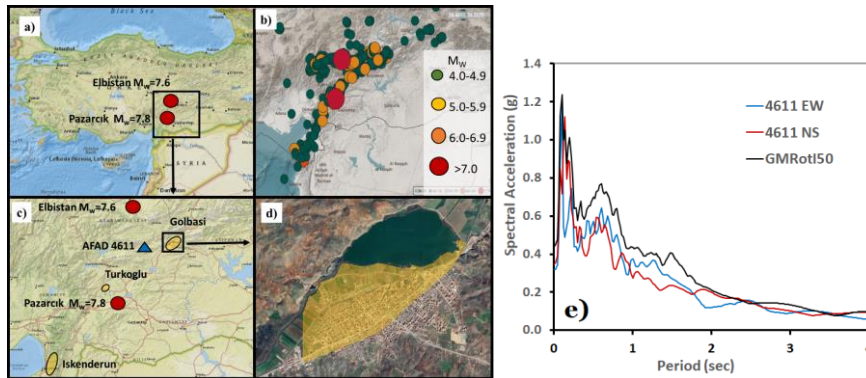
71% of the Gölbaşı District's critical infrastructure is damaged or completely devastated. Most buildings have suffered damage due to liquefaction as indicated by the yellow shaded zone in Figure 1d. In this area, a significant scale of the devastation became evident, with more than 1,350 buildings (1–8 stories) collapsed, and the rest of the buildings were significantly impacted by soil liquefaction. This paper explicitly presents the post-earthquake investigations at 3 liquefied sites and 4 buildings that were not damaged, moderately, and extensively damaged within the liquefied sites in Adıyaman-Gölbaşı during the 06 FEB 2023 earthquakes. The post-earthquake survey was performed on 17-22 JUNE 2023. First, the CPTu tests were conducted to determine the thickness and depth of the clay-like and sand-like layers. Soil strata that dominated the liquefaction-triggered conditions were examined from the soil behavior type index (I_c). By the soil type index, it is possible to predict if the soil behavior is controlled mainly by fines or sand since the cone responds to the in-situ mechanical behavior of the particular soil [2].

Fig 1. The 06 FEB 2023 earthquakes, $M_w > 7$ (a) epicenters, (b) aftershocks with $M_w > 4$, (c) the areas where the liquefaction occurred (highlighted in yellow), (d) the area where liquefaction was observed in the City of Gölbaşı (painted in yellow), and (e) spectral acceleration of station for E-W and N-S directions and calculated geometric mean

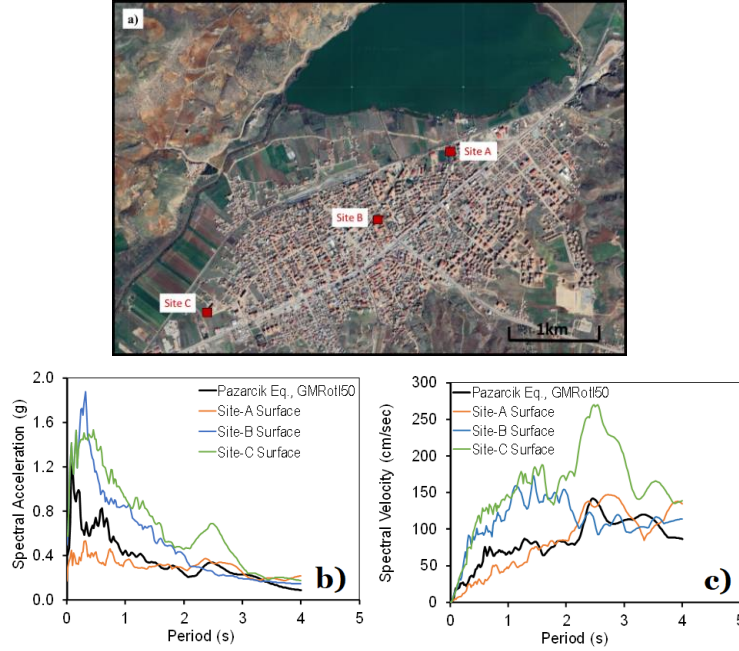
Fig 4. (a) Locations of 3 investigated sites, (b) acceleration, and (c) velocity response spectra at sites A, B, and C.

To estimate the Peak Ground Acceleration (PGA) and Velocity (PGV) at the sites, GMRotI50 data shown in Figure 1c were firstly converted to usable data suggested by the Turkish Building Earthquake Code, TBEC [12] for V_s of 730m/s soil zone, then it was used for the 1D seismic response of the soil profile for each site. The elastic acceleration response spectra on the ground surface at each site are shown in Figures 4b and c. The maximum PGV value of Station 4611 is about 40 cm/sec. The PGV values are estimated to be 118, 120, and 108cm/sec for Sites A, B, and C, respectively. It indicates that even though the PGA values tend to drop for Site A, PGV values of all sites are comparable, and there is a heavy damage potential of the ground motions in all sites.

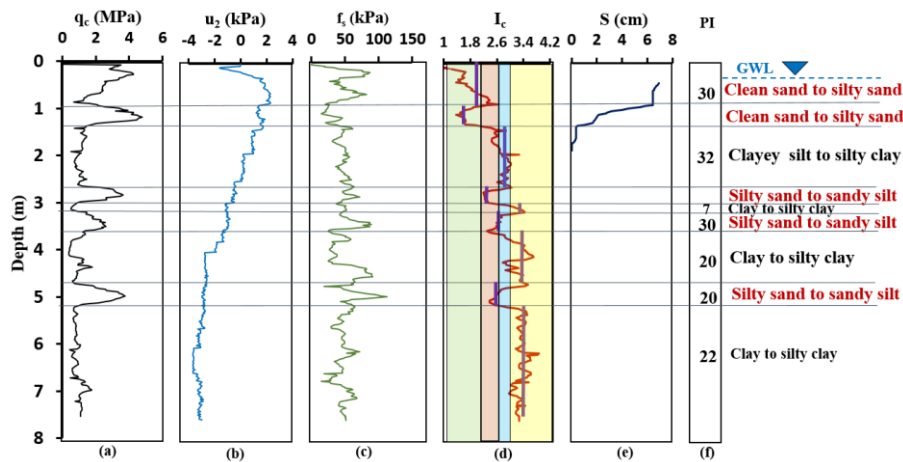
The soil profile was examined in the upper 7.5m below-ground surface with the q_c , f_s , and Δu_2 profiles (Figures 6a–c). Site A's GWT was about 0.21m below the ground surface. Figure 6d shows the soil stratigraphy accomplished by the charts that linked cone parameters to soil type. Based on CPT-based soil type, the sand-like soils written in red (shown in Figure 6d), tend to have $I_c < 2.61$, which is believed to be

Fig 6. (a) Cone penetration resistance, (b) friction resistance, (c) pore water pressure versus depth, (d) soil behavior type index based on interpretation from CPTu, (e) calculated free-field settlement according to [3], and (f) PI and soil type according to [11] at Site A.

Moreover, the post-liquefaction volumetric reconsolidation settlement at the free field up to 2m depth was calculated [3] and plotted in Figure 6e. The settlement at the ground surface was calculated to be 69.5mm. No liquefaction manifestation was observed at Site A. According to the laboratory tests before the earthquake, from 1.5m to 2.5m, the average plasticity index (PI) was determined as 32. From 5.0 to 7.5m, the average PI is determined as 20 (Figure 6f). There was no settlement measured at building A-1 (Table 1). The improvement of the foundation soil below the building by jet grout columns can be the reason for having no manifestation of liquefaction failure at the building.

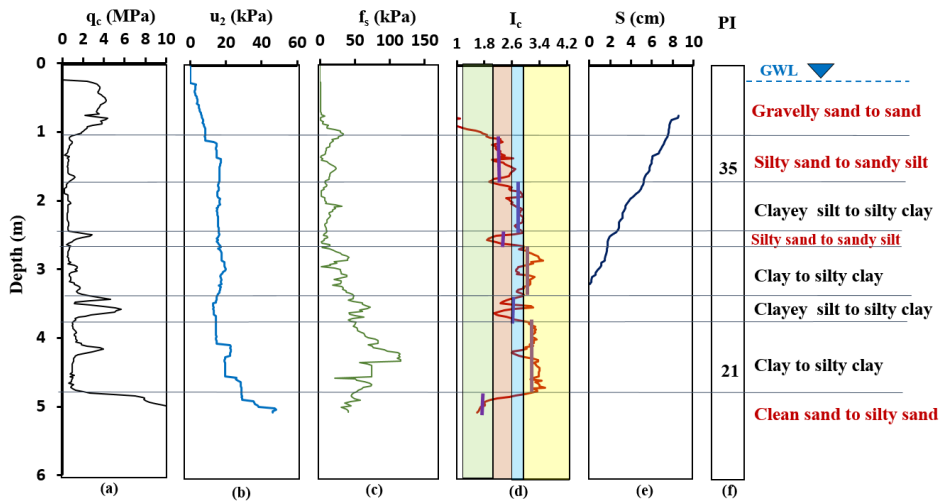
The soil profile was examined in the upper 5.2m below-ground surface with the q_c , f_s , and u_2 profiles (Figures 8a–b–c). The GWT depth at Site B was 0.15m. Based on the I_c -depth shown in Figure 8d, this site had a highly stratified profile. The sand-like soils written in red, tend to have $I_c < 2.61$, which is believed to be liquefiable [5]. Moreover, the post-liquefaction volumetric reconsolidation settlement at the free field up to 3.3m depth was calculated [3] (Figure 8e). The settlement at the ground surface was calculated to be 85.5mm. The liquefaction manifestation as bulging and settlement of the soil was observed at Site B. The S-E and S-W corners of the B-2 structure settled 116cm and 15cm, respectively, relative to the structure's N-W corner. The structure settled differentially about 116cm toward the S-E edge. The building tilted 3.03° to the east (Figure 7a) and 0.75° to the south (Figure 7b). The PI was measured 35 at SM to the sandy silt layer. This shows that the soils with high PI > 10% can also liquefy.

Fig 8. (a) Cone penetration resistance, (b) friction resistance, (c) pore water pressure versus depth, (d) soil behavior type index based on interpretation from CPTu, e) calculated free-field settlement according to [3], and f) PI and soil type according to [11] at Site B.

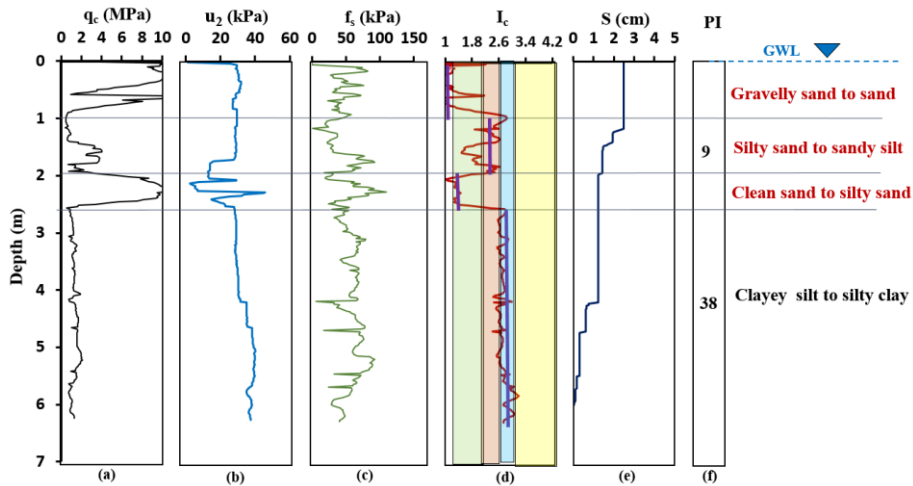
The soil profile was examined by 6.2m deep CPTu test results (Figures 10a–b–c). Based on the I_c shown in Figure 10d, this site had the same soil profile from 2.5 to 6.2m. The sand-like soils which are believed to be liquefiable were written in red [5]. Moreover, the post-liquefaction volumetric reconsolidation settlement at the free-field up to 6m depth was calculated [3] (Figure 10e). The settlement at the ground surface was calculated to be 25mm. The liquefaction manifestation as bulging, settlement,

and sand boiling was observed at Site C. The PI was measured 9 at SM to sandy silt layer.

Fig 10. (a) Cone penetration resistance, (b) friction resistance, (c) pore water pressure versus depth, (d) soil behavior type index based on interpretation from CPTu, (e) calculated free-field settlement according to [3], and (f) PI and soil type according to [11] at Site C.
